[Docket No. 2004-NE-07-AD; Amendment 39-13579; AD 2004-08-10]

Airworthiness Directives; Engine Components Incorporated (ECi) Reciprocating Engine Cylinders

2004-08-10 Engine Components Incorporated (ECi): Amendment 39-13579. Docket No. 2004-NE-07-AD.

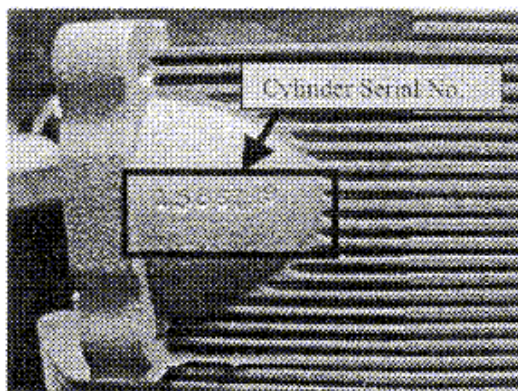
Figure 1.

(i) Determine the SN of the cylinder by looking in the engine records or by inspecting the cylinder for a SN on the intake port boss (see Figure 1) or on the flat area next to the head to barrel junction (see Figure 2). Disregard any dash numbers that might follow the four digit SN.

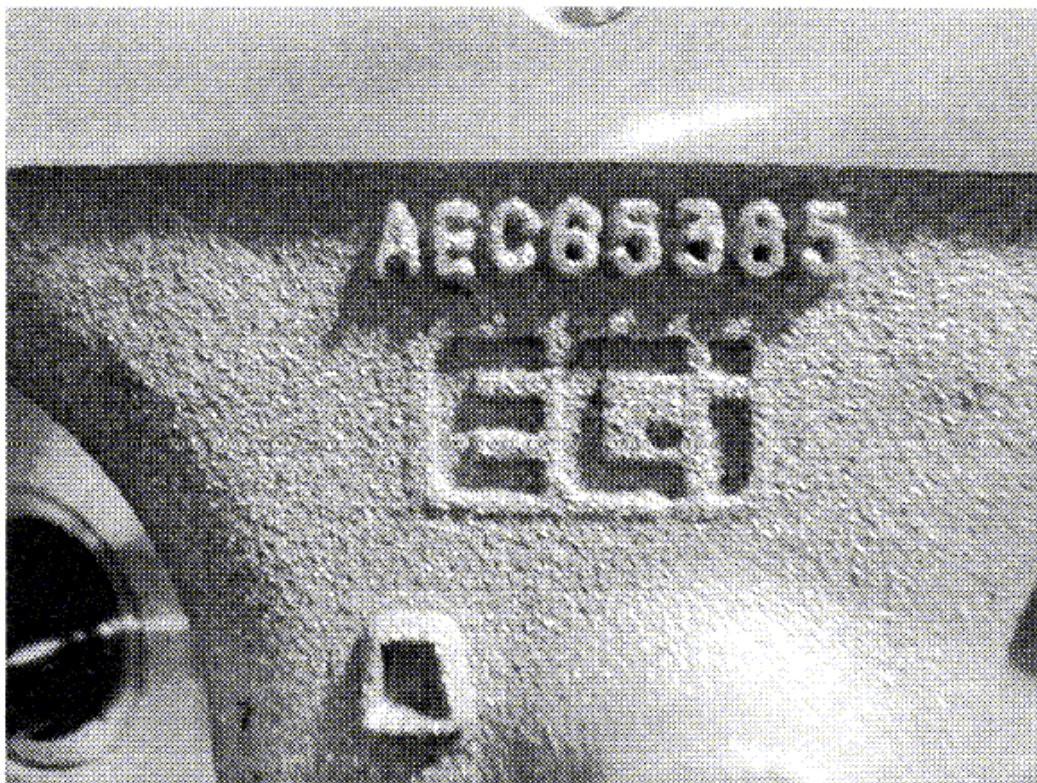
- (ii) If the SN is 1043 or lower, or if it is 7709 or higher, no further action is required.
- (2) If the cylinder SN is 1044 through 7708, do the following:
 - (i) Remove the rocker box cover from the cylinder.
 - (ii) Look at the left-front cylinder casting.
 - (iii) If the casting has AEC65385, and an "O" under the ECi logo, the cylinder is P/N AEC631397. See Figure 3.

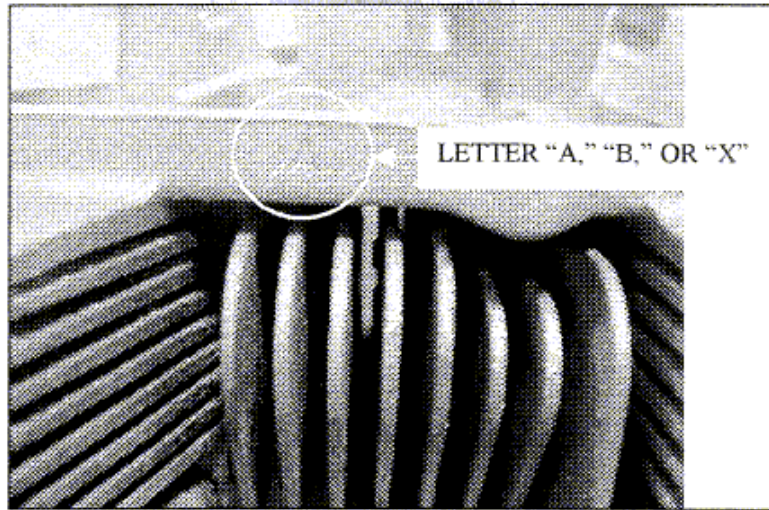
- (iv) If the cylinder is not ECI P/N AEC631397, no further action is required.
- (3) If the cylinder is ECI P/N AEC631397, do the following:
 - (i) Look at the flange of the rocker box.
 - (ii) If there is a letter "A," "B," or "X" stamped on the flange of the rocker box, no further action is required. See Figure 4.

- (iii) If there is no letter "A," "B," or "X" stamped on the flange of the rocker box, replace the cylinder before further flight.
